OREGON FUEL INJECTION, INC.

2001 – 2007 6.6L Duramax Diagnostics

High Pressure Common Rail Basic Information

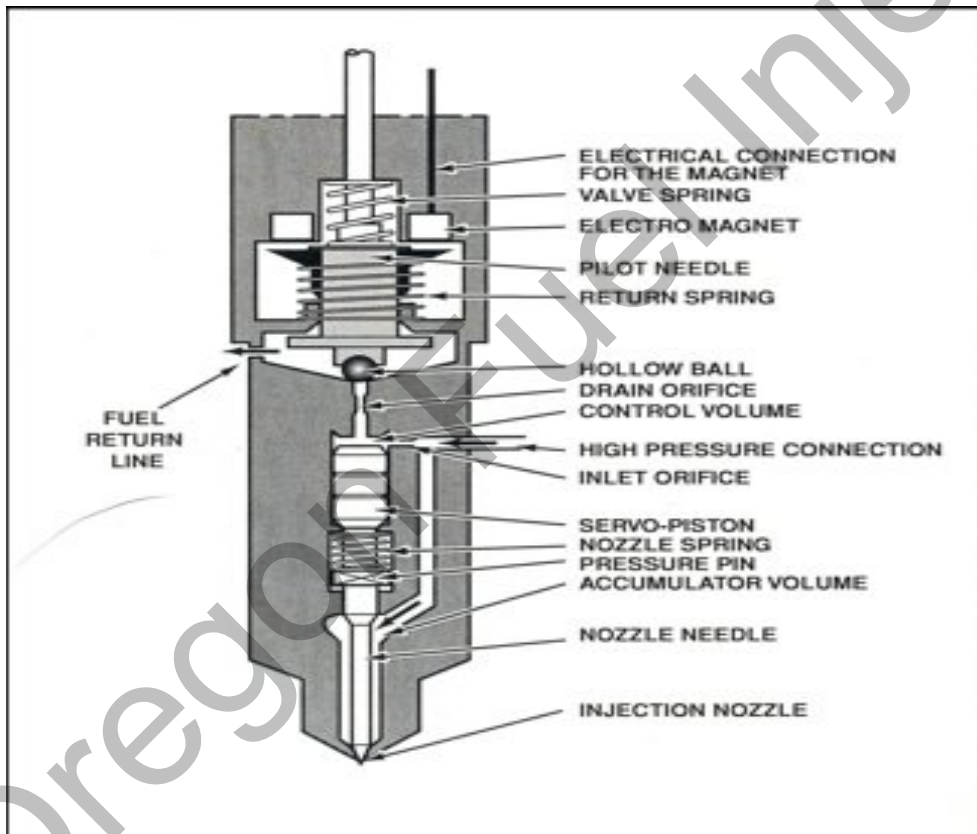
The high pressure pump builds rail pressure and delivers it to the fuel rail manifold where it flows through the injector lines to the injectors. The fuel pressure regulator in the high pressure pump controls rail pressure. The injectors have a hollow check ball that holds high pressure fuel until the fuel solenoid is actuated by the ECM, this allows the check ball to rise off its seat and an injection to take place. If the check ball in the injector is leaking due to erosion on the seat or the high pressure limit valve leaks then it will not build enough rail pressure to start the engine. It takes approximately 2500 PSI rail pressure to start.
